U.S. DEPARTMENT OF
ENERGY

Legacy
Management

2021 Annual Site Inspection and Monitoring Report for Uranium Mill Tailings Radiation Control Act Title I Disposal Sites

March 2022

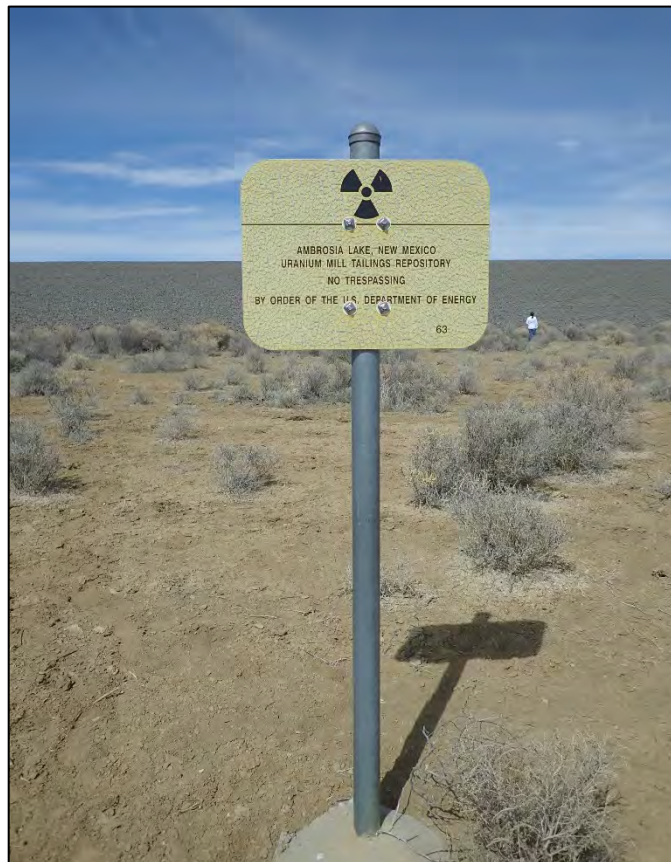
There are 70 perimeter signs, attached to steel posts set in concrete, positioned along the unfenced property boundary (PL-2). Posts for perimeter signs P1 through P15 include additional warning signs about mining restrictions. Many of the perimeter signs were cracked and weathered but remain legible. Erosion has occurred around the base of perimeter sign P12, but the perimeter sign is stable (PL-3). A new prairie dog colony was identified between perimeter signs P17 and P18. It does not threaten the integrity of either perimeter sign, no additional action is needed. No maintenance needs were identified.

PL-2. Perimeter Sign P63

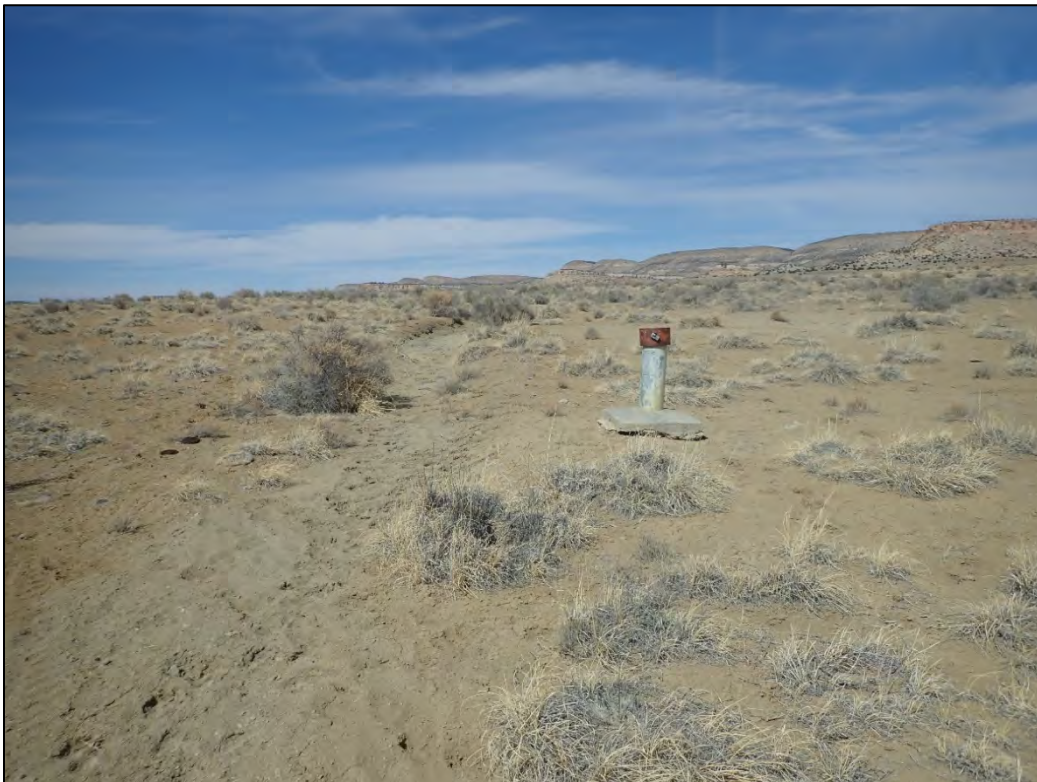
The site has three monitoring wells. A gully adjacent to well 0678 appears to be stable, and the well is not affected by the erosion (PL-6). All wellhead protectors observed during the inspection were undamaged, locked, and properly labeled. No maintenance needs were identified.

PL-6. Erosional Rills Around Monitoring Well 0678

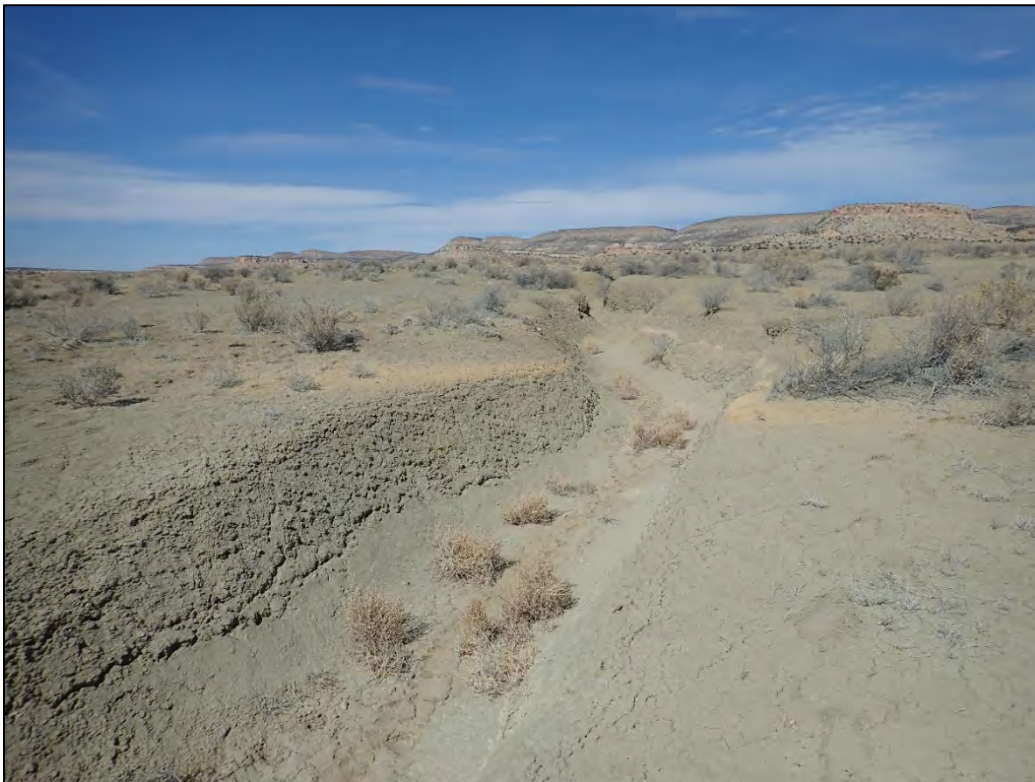
Onsite rills and gullies north and east of the disposal cell have been visually monitored for several years. While no new rills and gullies were observed during the 2021 annual inspection, existing rills and gullies continued to develop. One gully, northeast of the disposal cell, has grown to a depth of 6–8 feet and a width of 8–10 feet (PL-12). Inspectors collected GPS locations and measurements of this gully and its location has been updated on the inspection map. These erosional features do not threaten the disposal cell's performance or integrity, because headward erosion is progressing away from the disposal cell, and there is no significant sedimentation near the disposal cell. No maintenance needs were identified.

PL-12. Erosional Gully Northeast of Disposal Cell

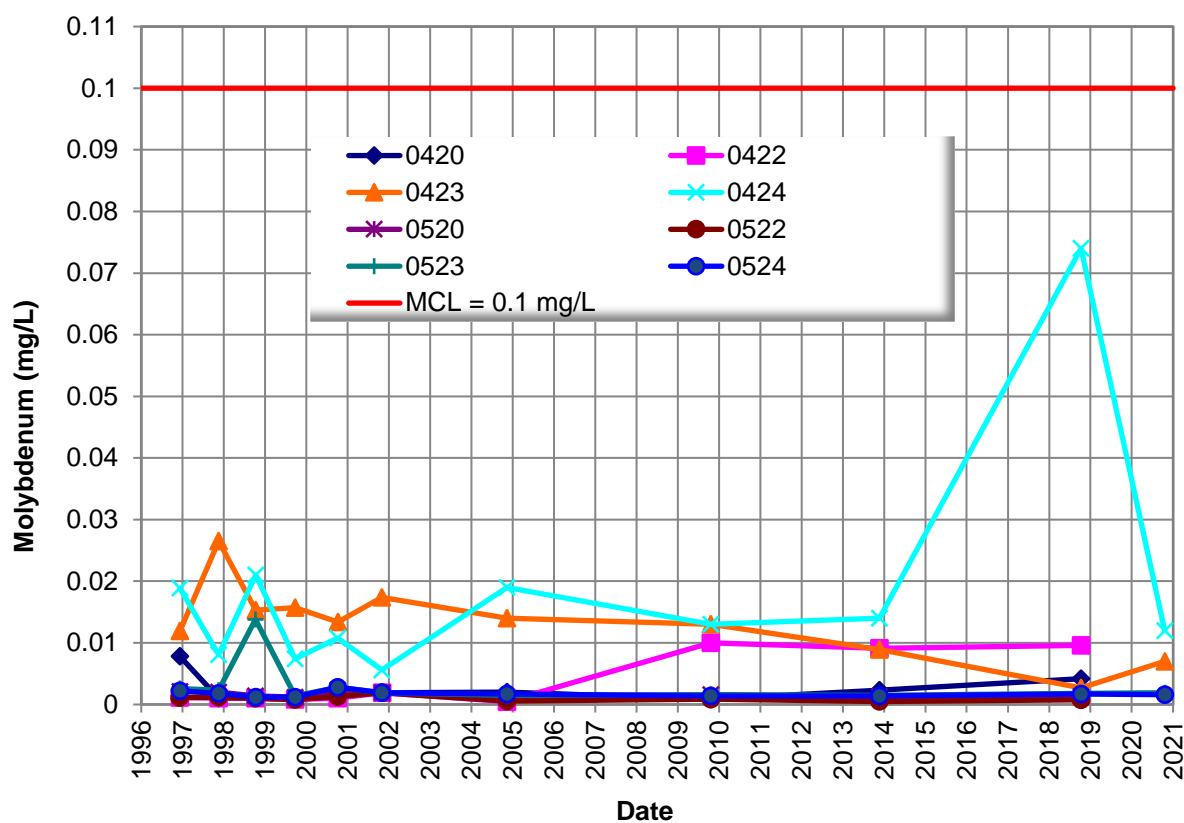
The molybdenum concentration measured in monitoring well 0424 in 2020 was 0.012 milligrams per liter (mg/L), which shows that the potentially significant increasing trend between 2013 and 2018 was not persistent (Figure 2-3). Concentrations for lead, selenium, and uranium measured in 2020 were all well below their respective MCLs (Figure 2-4, Figure 2-5, and Figure 2-6). Lead showed a downward trend in well 0423 (Figure 2-4) and uranium showed a downward trend in wells 0423 and 0424 (Figure 2-6). Selenium has an upward trend for all wells, but concentrations remain below the respective MCL (Figure 2-5). Selenium trends will be evaluated again in 2023 after the next schedule 5-year sampling event.

Figure 2-3. Molybdenum in Groundwater at the Burrell, Pennsylvania, Disposal Site

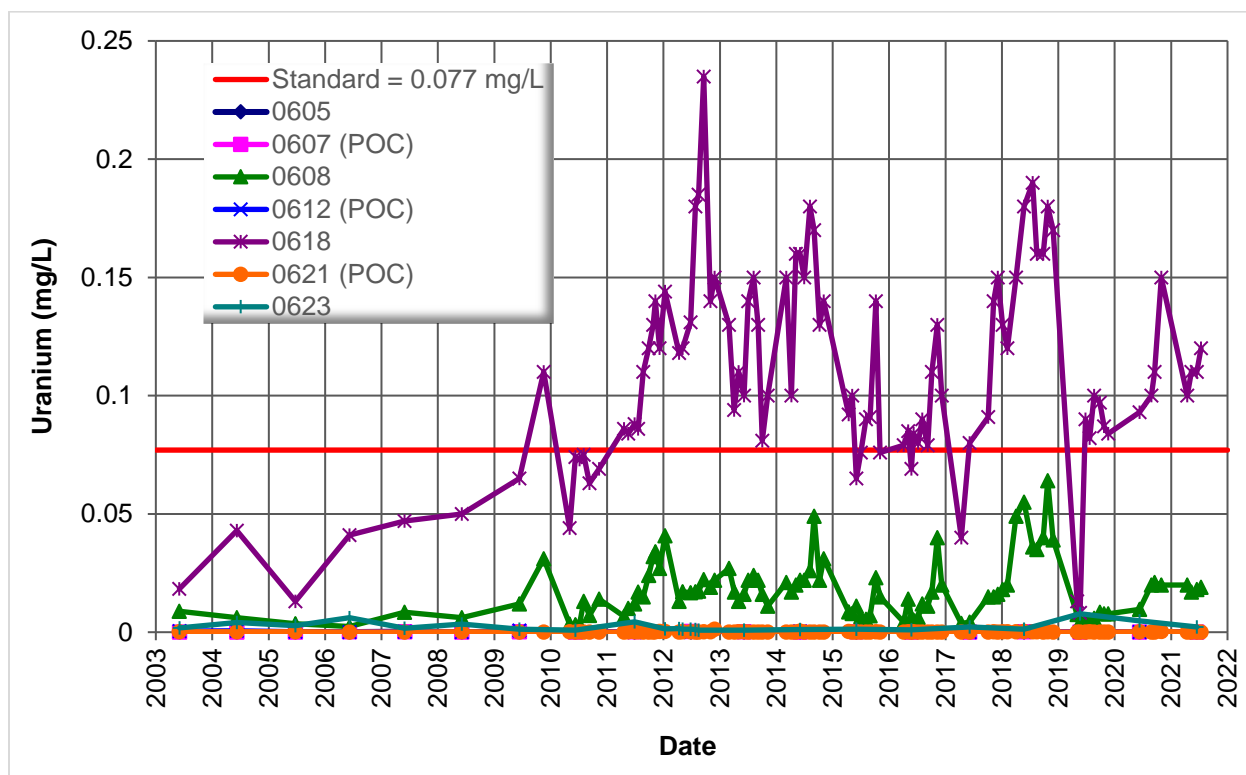
Figure 4-5. Uranium Concentrations in Groundwater at the Durango, Colorado, Disposal Site

Wells completed in the alluvium are sampled as a BMP. Uranium concentrations in well 0618 have consistently been higher than concentrations in the other onsite wells. To monitor and compare the elevated and variable uranium concentrations observed in this well, BMP wells 0608, 0618, and 0621 are sampled monthly as weather permits. Figure 4-5 shows variable uranium concentrations between 0.0082 milligrams per liter (mg/L) and 0.235 mg/L in well 0618 beginning in 2009 and continuing to the present. Uranium concentrations in well 0618 were measured at 0.12 mg/L in July 2021, which is within the range of measured historical concentrations. The cause of the variability in uranium concentration at well 0618 will be a focus of further investigation.

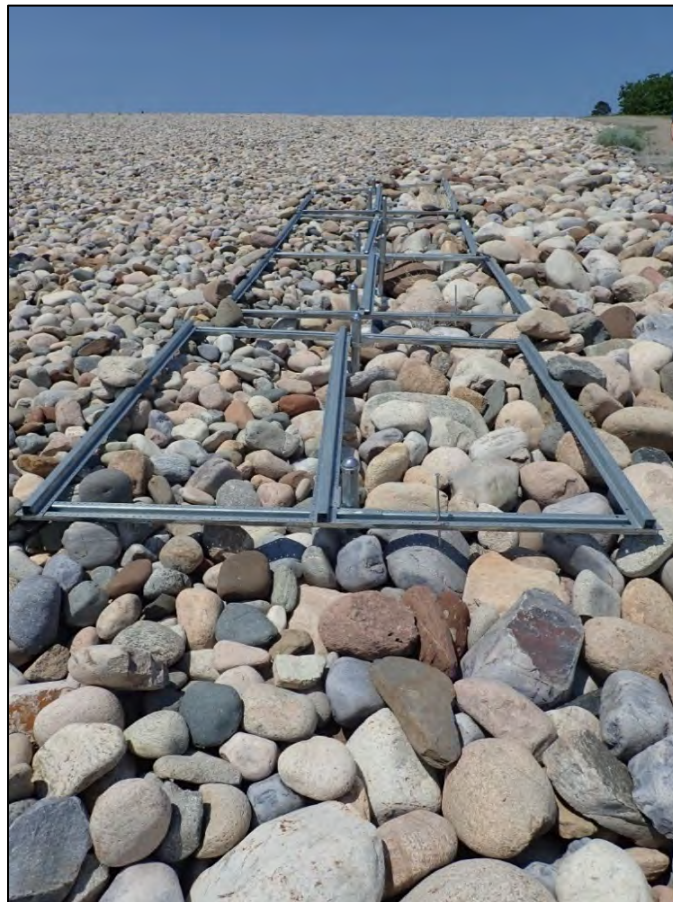
The side slopes of the disposal cell are armored with rock riprap. Rock has moved along the north toe of the disposal cell, resulting in a linear depression approximately 18 feet (ft) long (PL-4) that first was observed in 2015 and continues to be monitored. Inspectors did not observe significant changes to the depression. Inspectors will continue to monitor this area.

PL-4. Monitoring Grid over Linear Depression

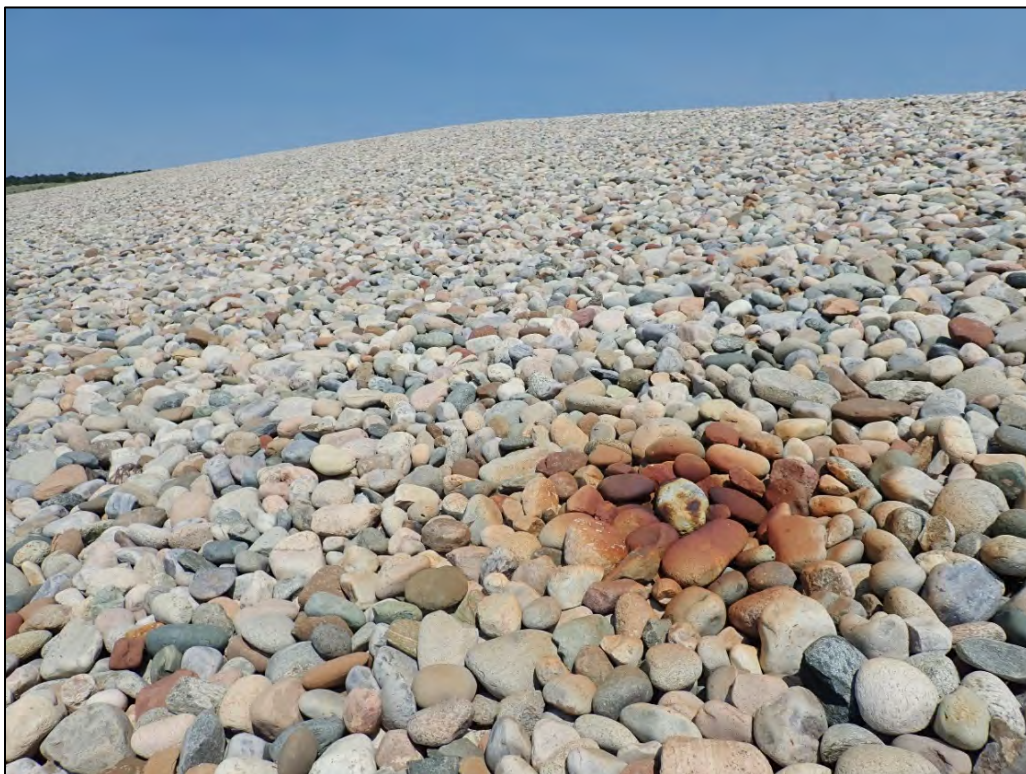
Inspectors found several young volunteer trees and several noxious weeds growing on the side slopes. The noxious weeds were treated after the inspection. Inspectors noted several points on the side slopes that had sustained lightning strikes (PL-5). No other maintenance needs were identified.

PL-5. Lightning Strike on Side Slope

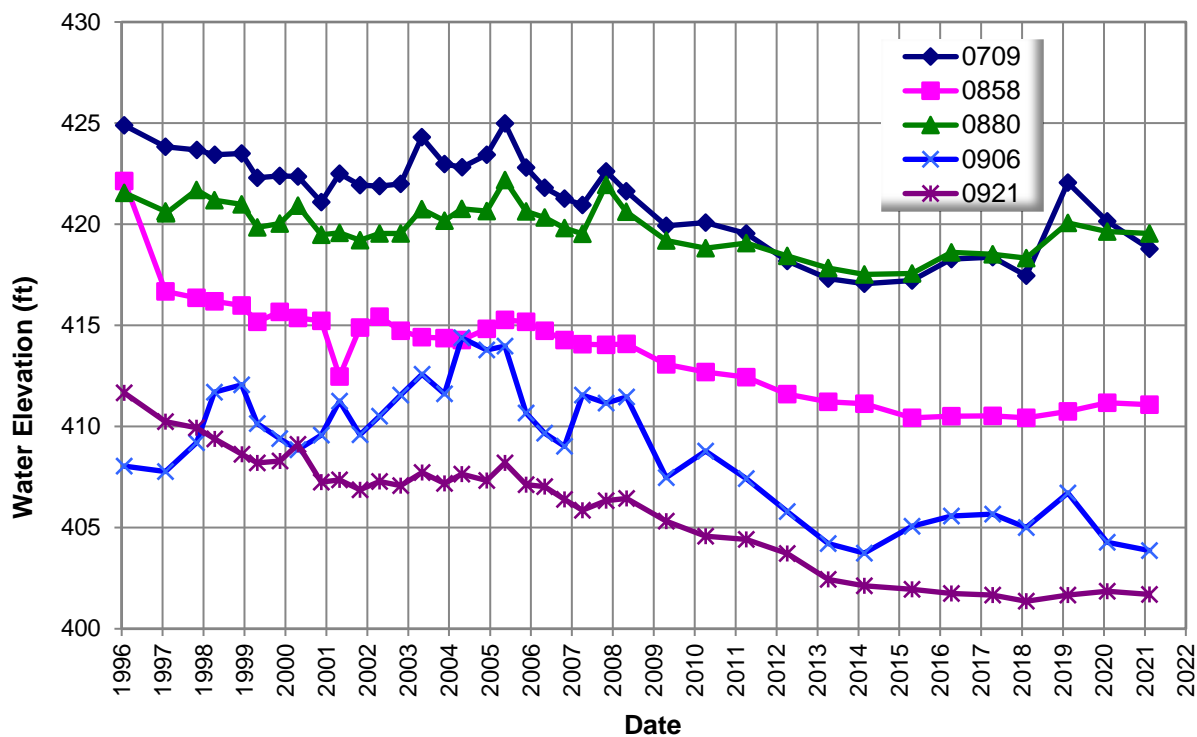
Figure 5-3. Water-Level Measurements at Disposal Cell Performance Monitoring Wells at the Falls City, Texas, Disposal Site

Water levels in all disposal cell performance wells had decreasing trends from 1996 to 2014 based on Mann-Kendall trend analyses (Figure 5-3). Water levels in these wells appear to have stabilized by 2014, but wells 0709, 0880, and 0906 have had increases in water level since 2014, which are more subtle in wells 0858 and 0921 (Figure 5-3). Groundwater compliance wells 0862, 0886, and 0963 had significant increasing water level trends since 1996, and wells 0891 and 0924 had no statistically significant trend (Figure 5-4). Wells with increasing water level trends each had a water elevation increase of about 5 ft since 1996.

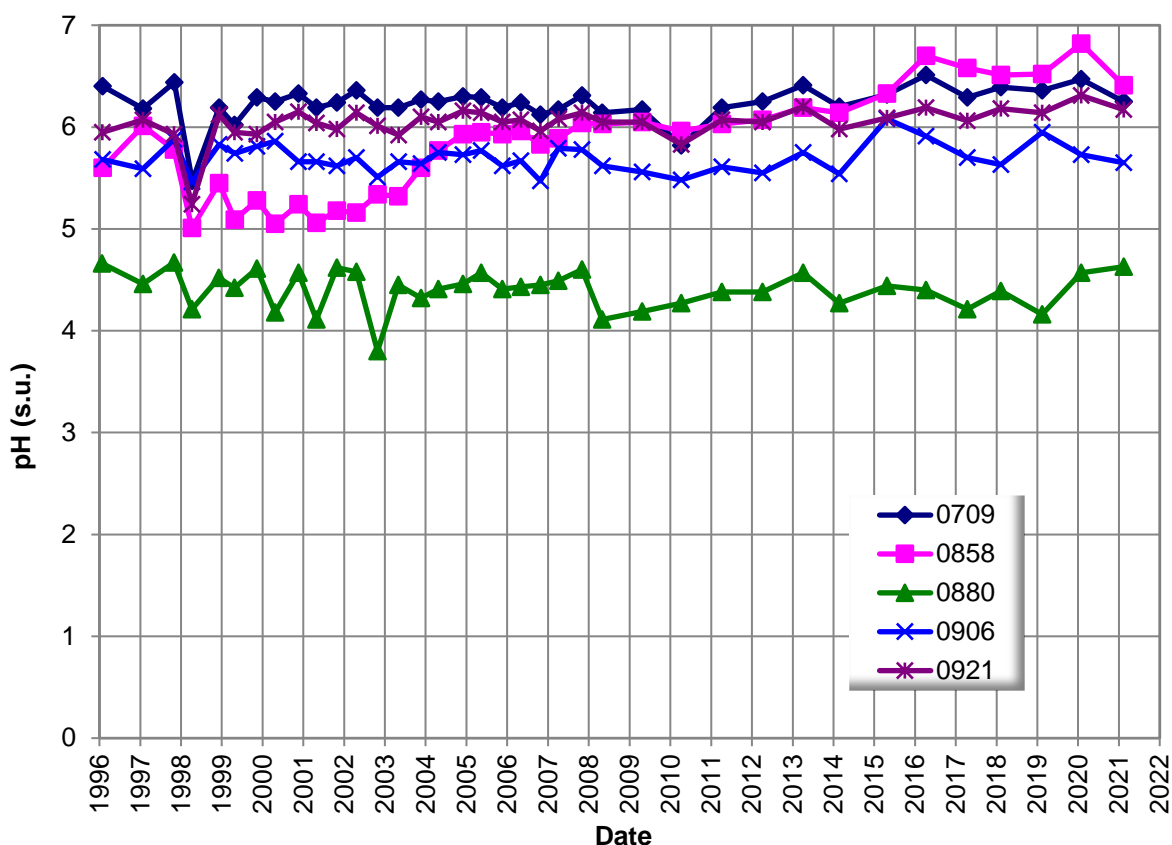
Figure 5-5. pH at Disposal Cell Performance Monitoring Wells at the Falls City, Texas, Disposal Site

pH: Wells 0858 and 0921 had significant increasing pH trends since 1996, based on Mann-Kendall trend analyses, and all other disposal cell performance wells had no significant trend. At the disposal cell performance monitoring wells, pH levels have historically been greater than the pH in tailings pore fluids (pH level of 2.93). The 2021 pH levels were within the range of historical values for all disposal cell performance monitoring wells (Figure 5-5).

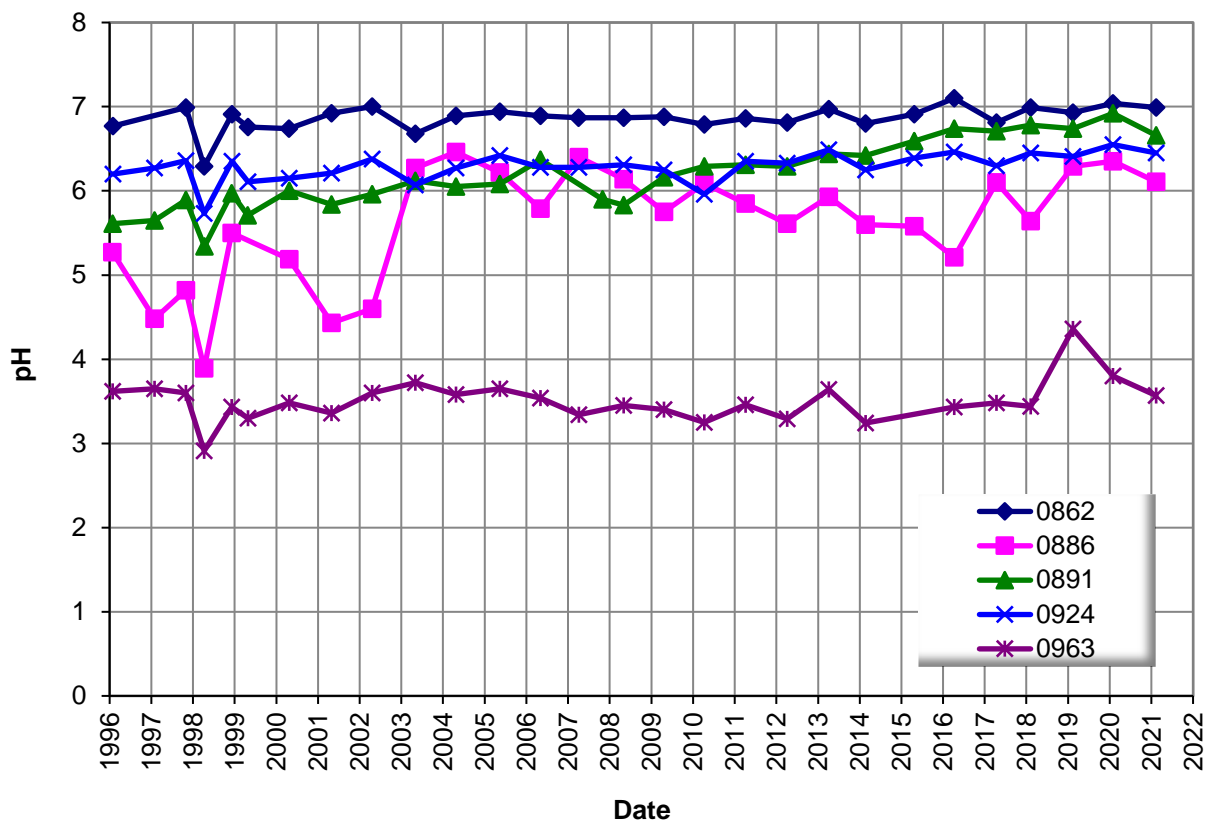
Figure 5-6. pH at Groundwater Compliance Monitoring Wells at the Falls City, Texas, Disposal Site

For compliance monitoring wells, statistically significant increasing trends in pH have been seen in wells 0886, 0891, and 0924 since 1996, with no significant trends in wells 0862 and 0963 (Figure 5-6). The 2021 pH levels were within the range of historical values for all groundwater compliance monitoring wells. The pH in monitoring well 0963 historically has been lower than at the other groundwater compliance wells, with a pH of 3.6 in 2021 compared to between 6.0–7.0 in the other wells. Overall, groundwater in well 0963 had a similar pH to that of the tailings pore fluids, even compared to the wells adjacent to the disposal cell.

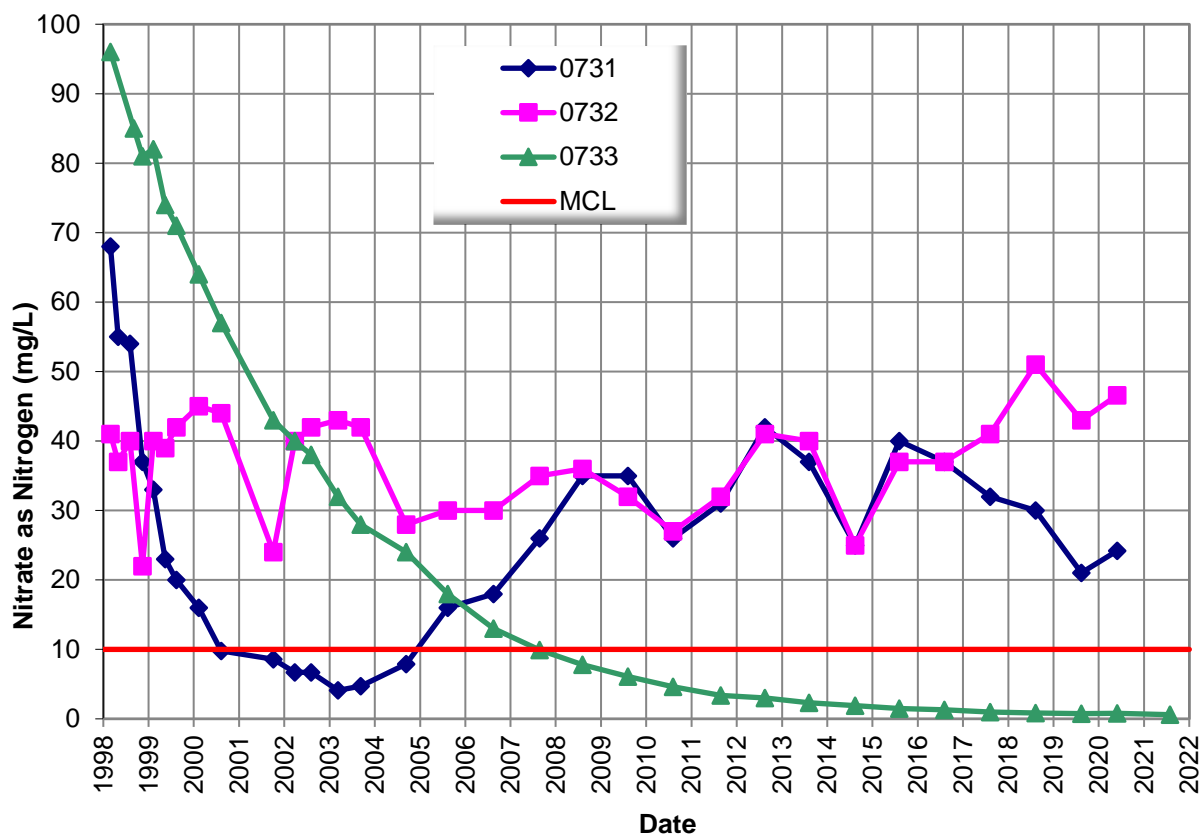
Figure 6-4. Nitrate (as Nitrogen) in Groundwater at the Grand Junction, Colorado, Disposal Site

Nitrate (as nitrogen) concentrations in disposal cell monitoring well 0733 continued to decline from 96 mg/L in 1998 to 0.6 mg/L in 2021; the 2021 numbers are significantly below the MCL of 10 mg/L (Figure 6-4). This is possibly due to increased reducing conditions (less oxygen) over time at the bottom of the disposal cell, creating denitrification (conversion of nitrate to nitrogen gas). Past concentrations of elevated nitrate (as nitrogen) in paleochannel monitoring wells 0731 and 0732 (compared to background nitrate concentrations up to 1.1 mg/L) may be the result of these wells adding oxygen to the Mancos Shale within the well screen and releasing nitrate.

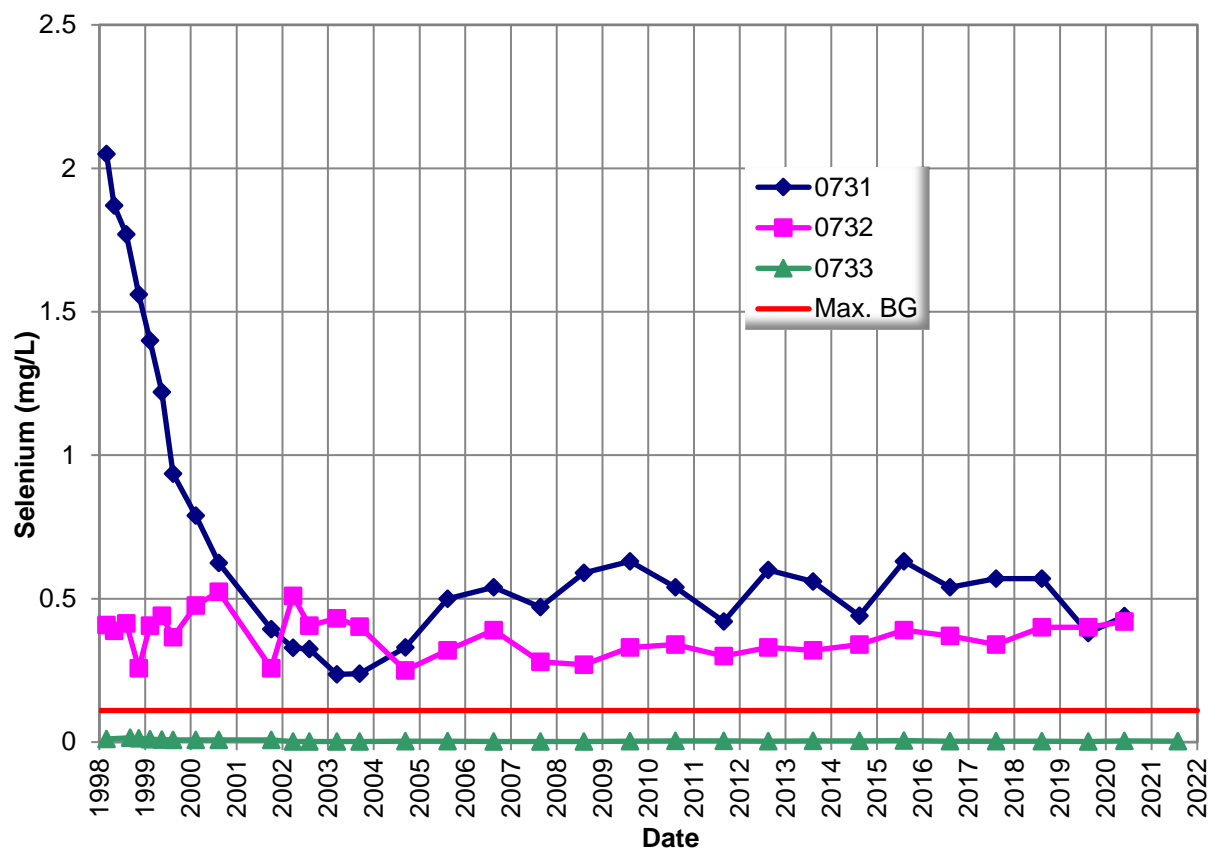
Figure 6-5. Selenium in Groundwater at the Grand Junction, Colorado, Disposal Site

Selenium occurs naturally in the Mancos Shale deposits that underlie the disposal cell (DOE 1991). Background groundwater concentrations in the Mancos Shale are at 0.11 mg/L, which exceeds the MCL of 0.01 mg/L (Table 6-3). As with nitrate, the addition of oxygen into the Mancos Shale because of the installation of these monitoring wells may contribute to the release of selenium from the Mancos Shale. Disposal cell monitoring well 0733 is not screened in the weathered Mancos Shale, and selenium concentrations remain below maximum background concentrations (Figure 6-5).

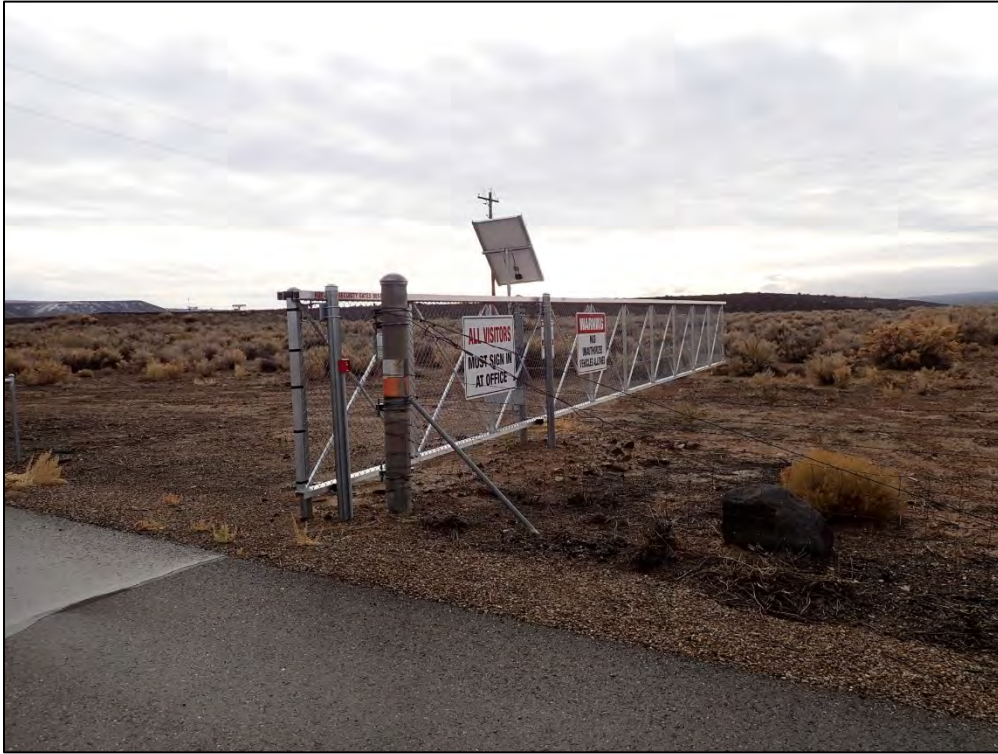
The site entrance gate was locked and functional, and site entrance signs on and next to the entrance gate were in good condition (PL-1). No maintenance needs were identified.

PL-1. Solar-Powered Site Entrance Gate

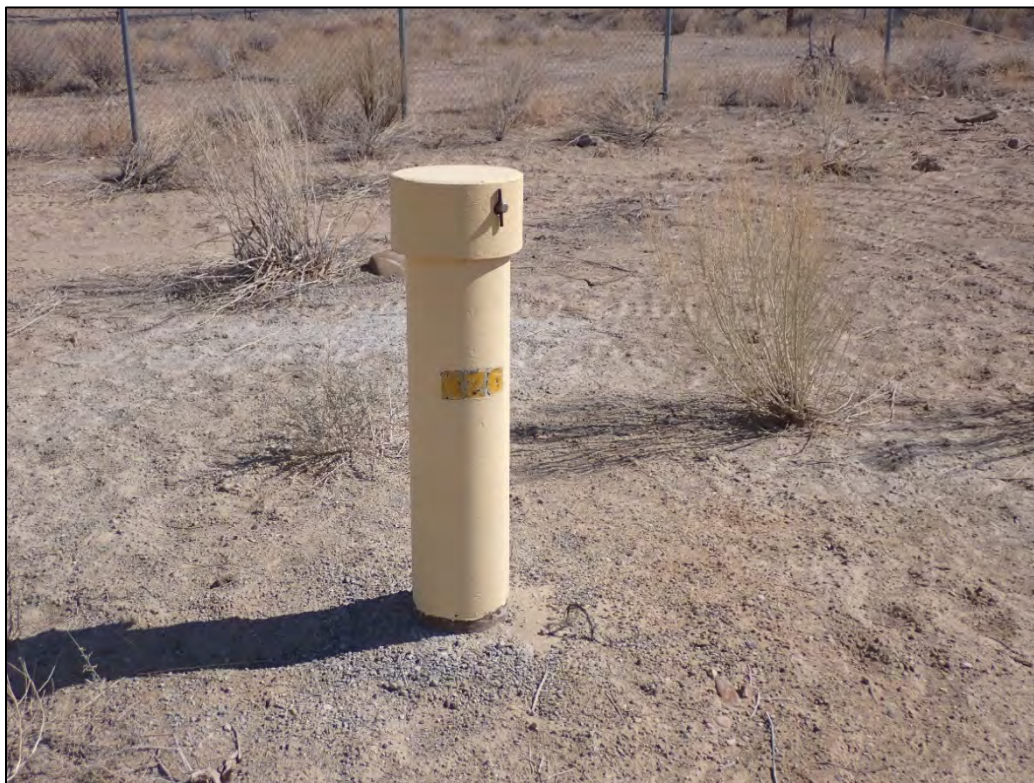
Twenty-two monitoring wells are on or near the site. The LTSP establishes four POC wells at the site for postclosure groundwater monitoring. All wellhead protectors observed during the inspection were undamaged and locked. Some of the concrete monitoring well collars were cracked, but the wellhead protectors were stable, and repairs are not necessary. Well identification numbers were faded or missing on several wells (PL-7). Well identification numbers will be reapplied before the next inspection.

PL-7. Faded Identification Numbers on Monitoring Well 0176

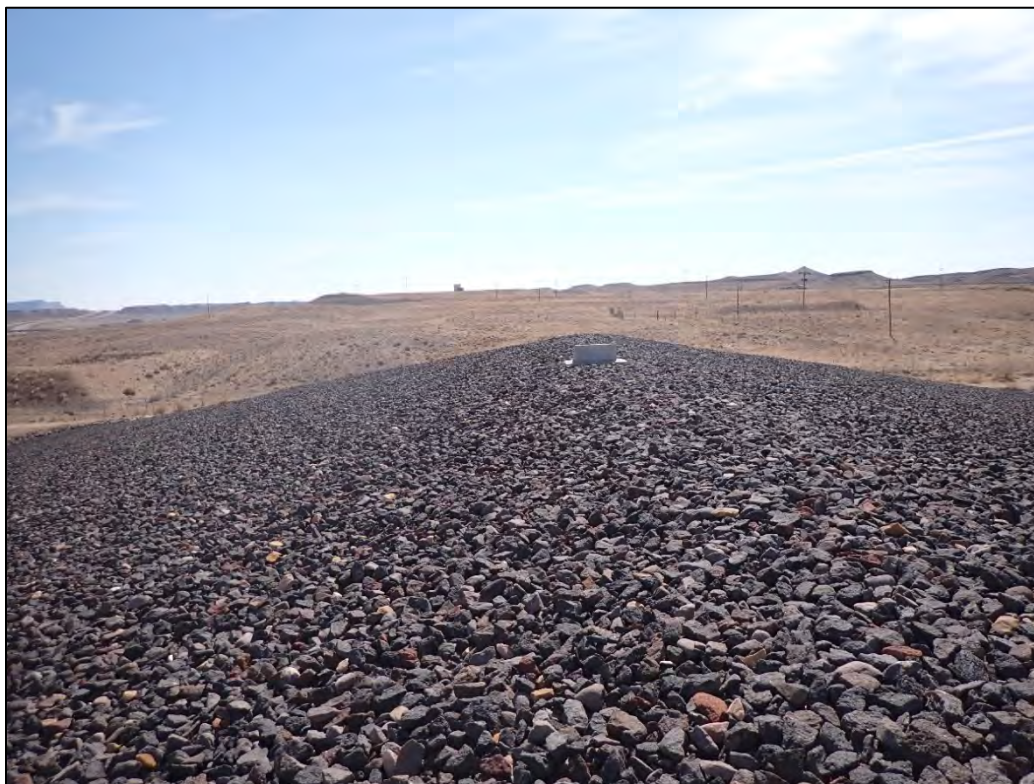
The disposal cell, completed in 1989, occupies 6 acres. The slopes of the disposal cell cover are armored with riprap, consisting primarily of competent basalt with a small fraction of sedimentary rocks, to control erosion. A small percentage of the rock, including basalt and sedimentary rock, has degraded, but the riprap cover is functioning as designed. Inspectors found no evidence of settling, slumping, erosion, or other modifying process that might affect the integrity of the disposal cell (PL-8, PL-9, and PL-10).

PL-8. Site Marker SMK-2 on Disposal Cell Top Slope

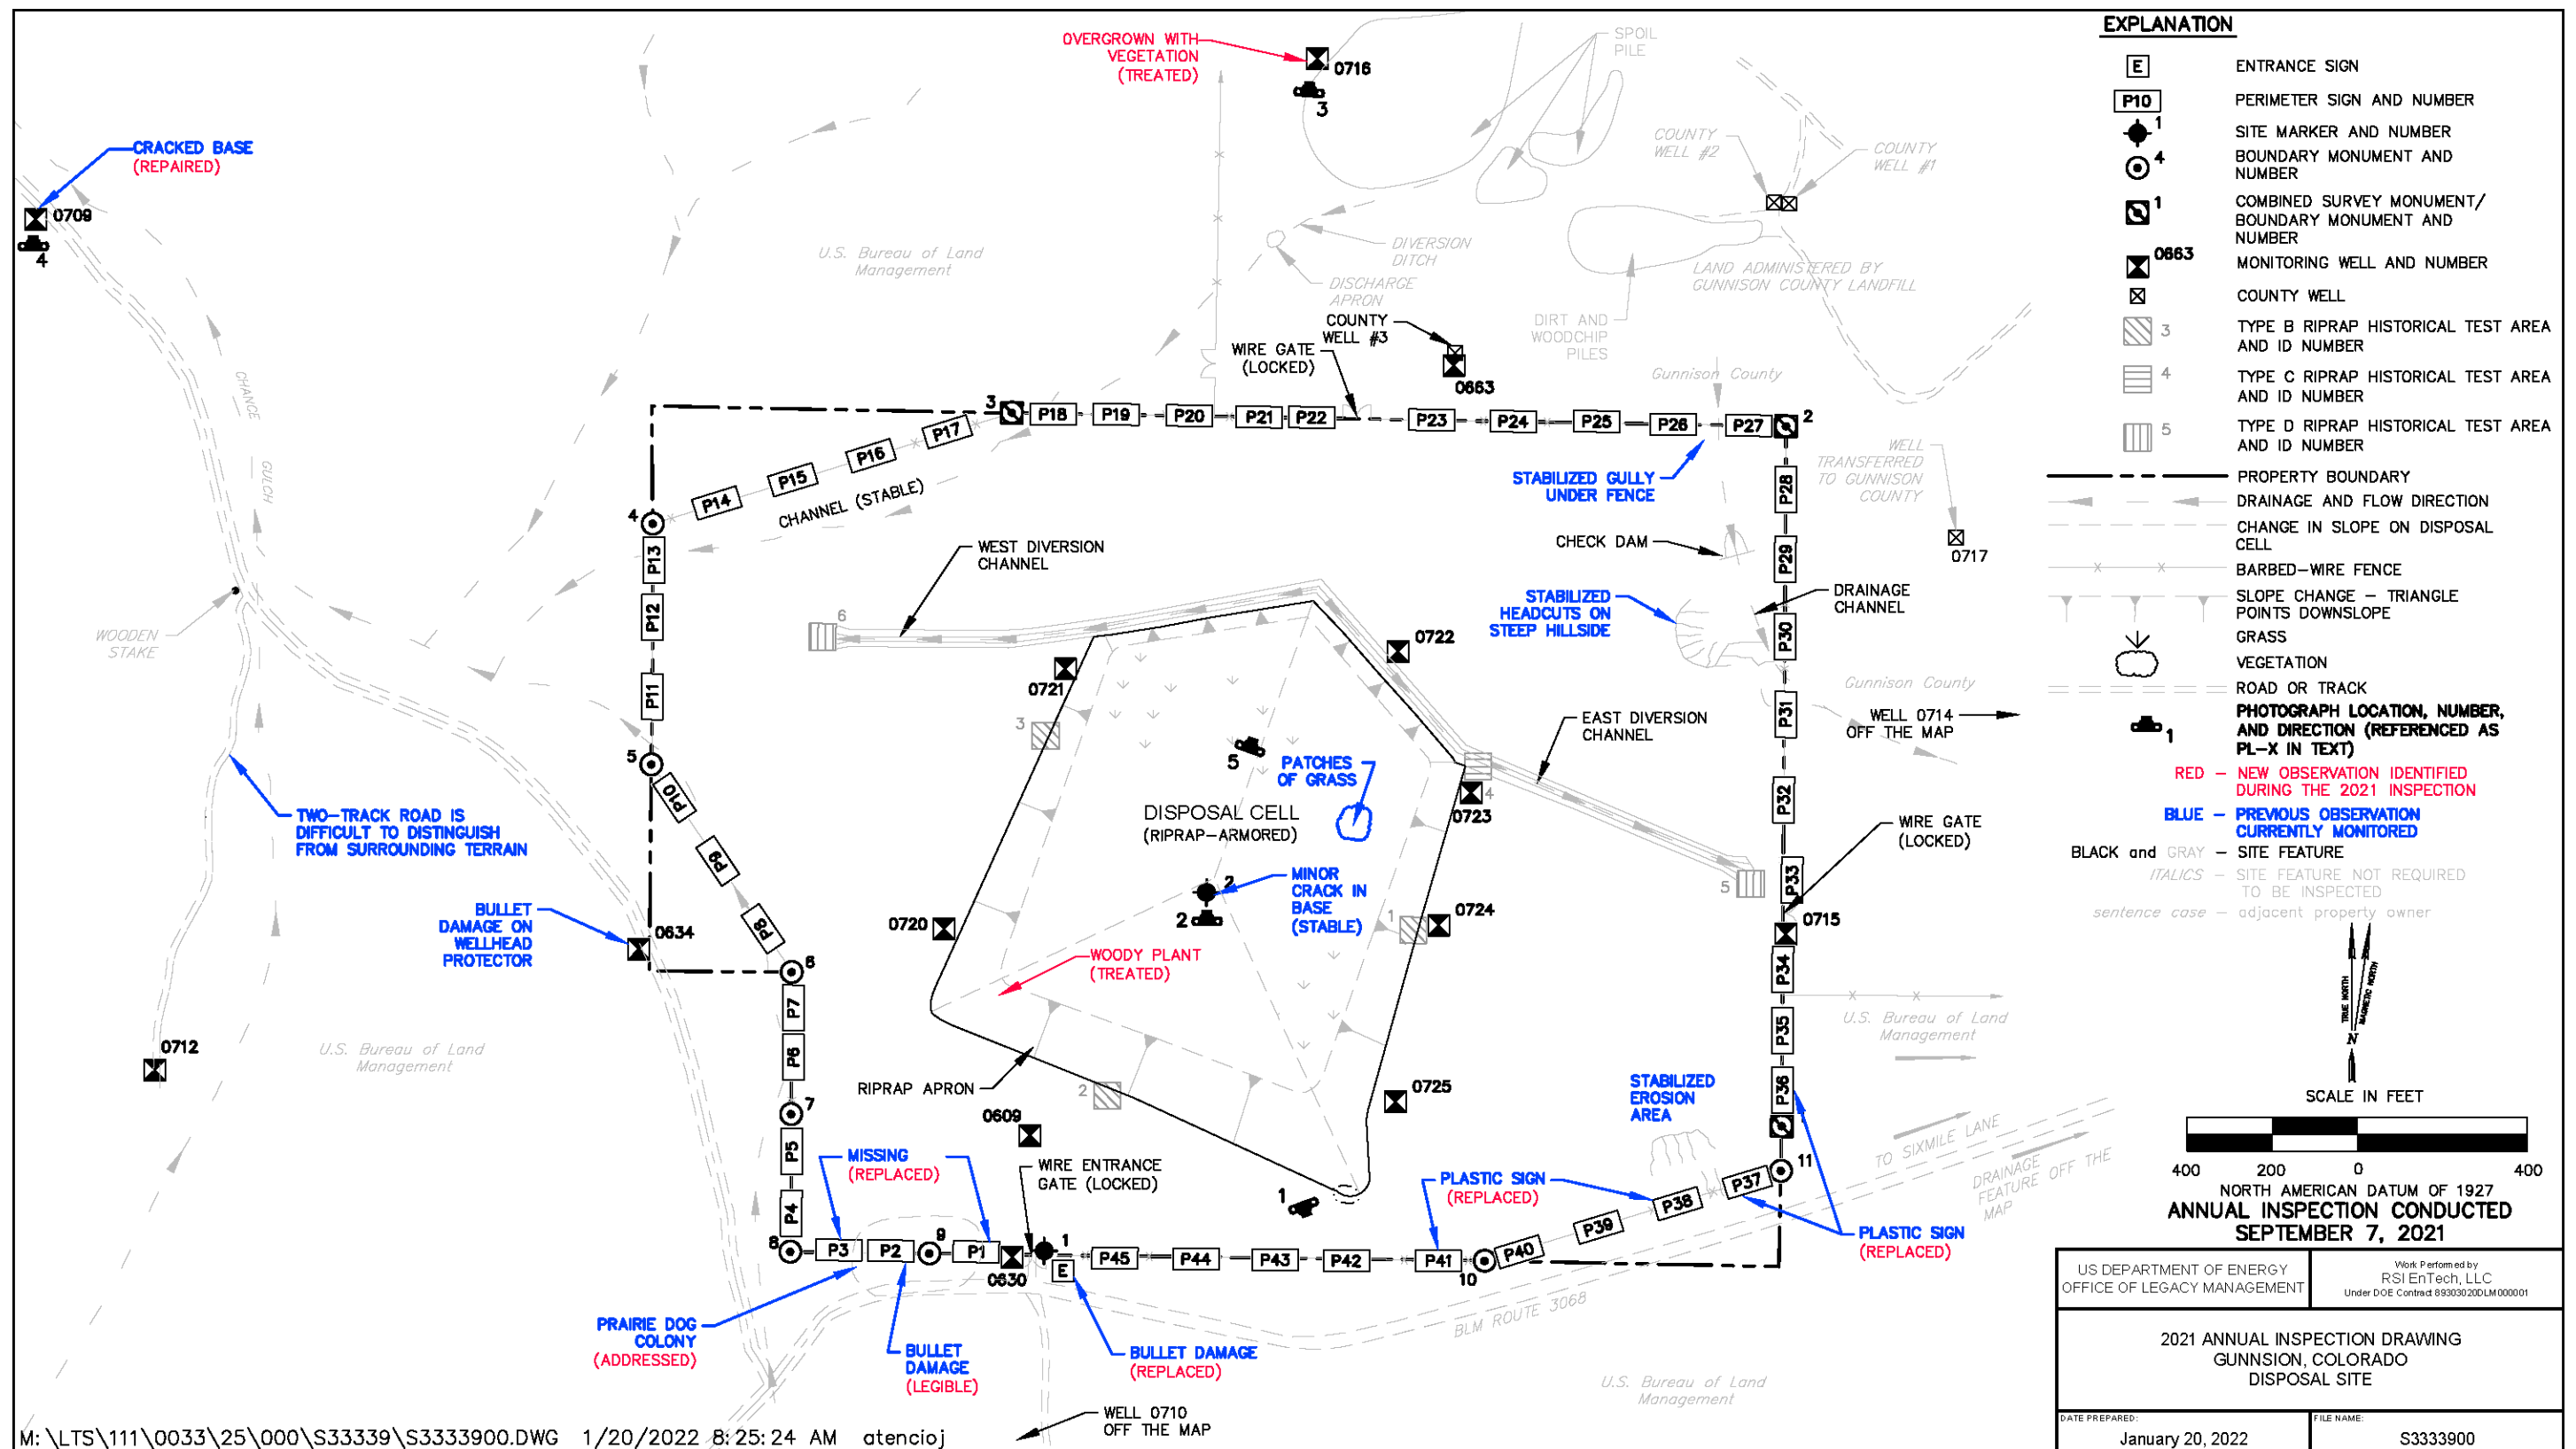
Figure 8-1. 2021 Annual Inspection Drawing for the Gunnison, Colorado, Disposal Site

Figure 8-1 shows the locations of site features, including site surveillance features and inspection areas, in black and gray font. Site features that are present but not required to be inspected are shown in italic font. Observations from previous inspections that are currently monitored are shown in blue text, and new observations identified during the 2021 annual inspection are shown in red. Inspection results and recommended maintenance activities associated with site surveillance features are included in the following subsections. Photographs to support specific observations are identified in the text and in Figure 8-1 by photograph location (PL) numbers. The photographs and photograph log are presented in Section 8.10.

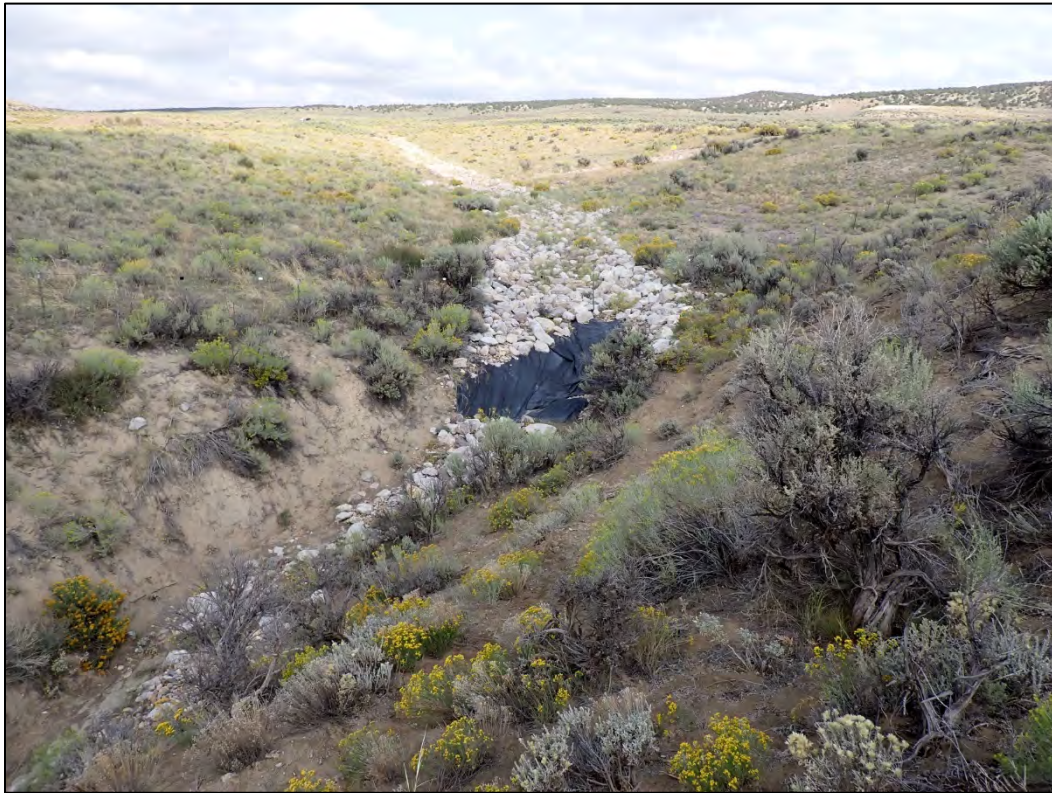
PL-13. Exposed Geofabric in Swale No. 1 Outlet

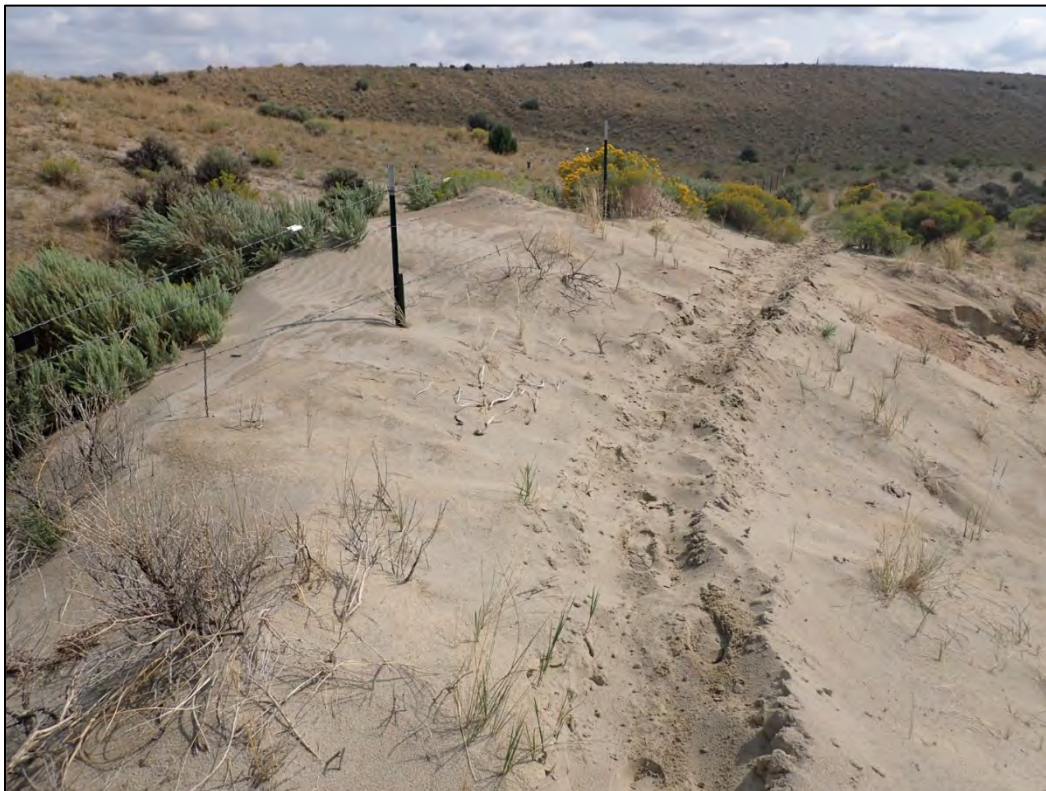
PL-15. Sand Accumulation Along Southern Fence Line Near Johnson Pit

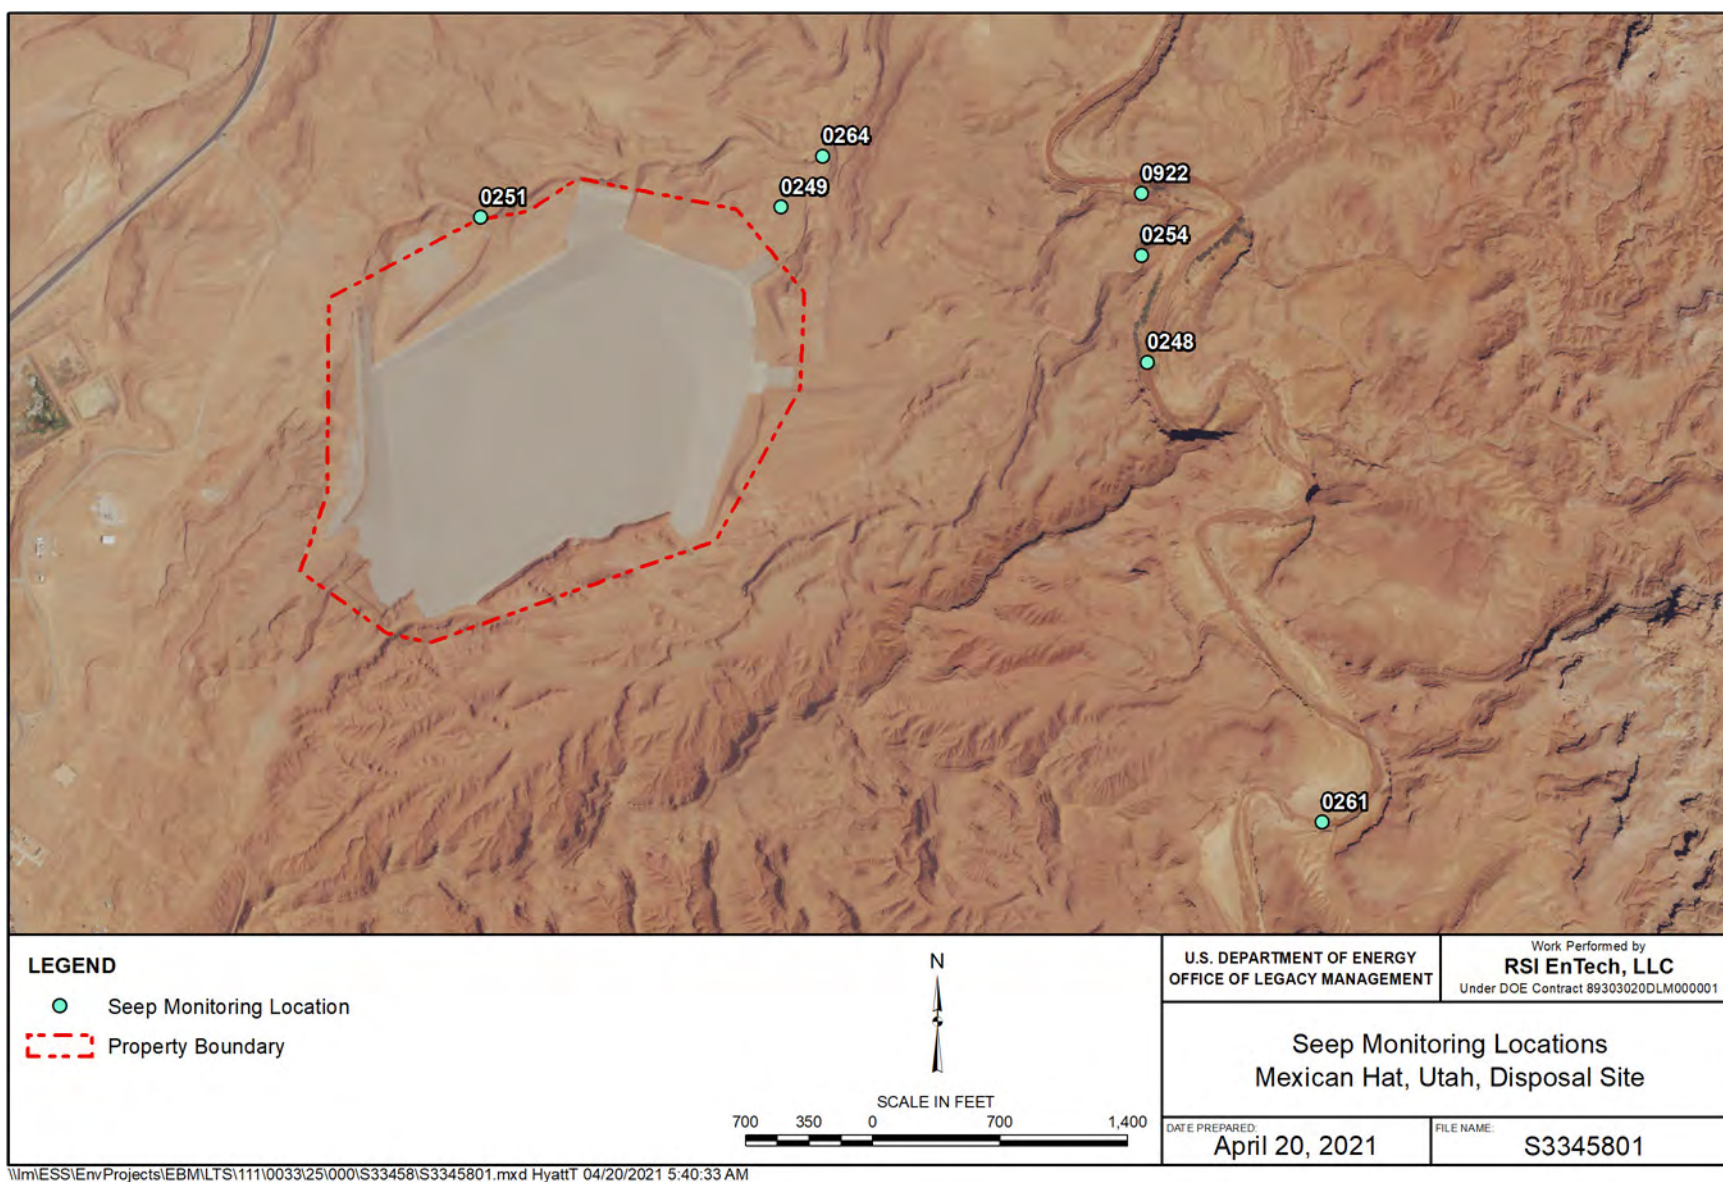
Figure 12-2. Seep Monitoring Locations at the Mexican Hat, Utah, Disposal Site

The remaining seeps identified in the annual monitoring plan exhibited dry conditions during the inspection. Table 12-2 documents the conditions of each monitored seep observed during the inspection with the respective drainage in which each seep occurs and a reference to photographic documentation.
